# MIB238

MULTIPURPOSE INTERFACE BOARD

TECHNICAL  
SERVICE BULLETIN

JL-MIB238-01  
REVISION A  
1/23/2021

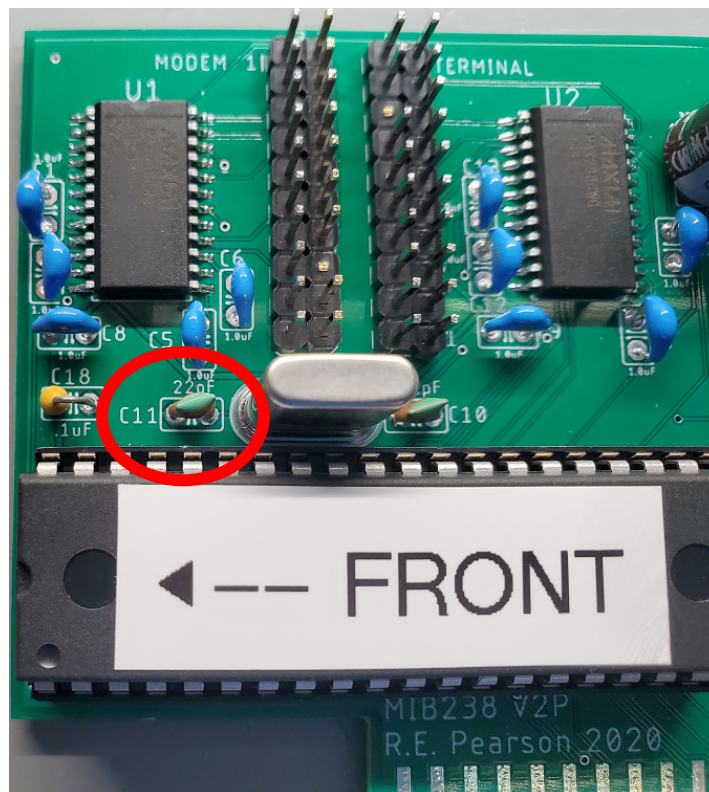
All MIB238 boards purchased from John Lundy prior to 1/1/2021 or any person who has built their own from Eric Person's GitHub project can experience inoperative or intermittent serial ports in some consoles but not others.

C11 must be removed from the board which can be done using a small pair of angled cutting dikes. More skilled users can desolder it. This procedure needs to be performed to all boards regardless of whether they have been working or not with any given console. C11 is located to the left of the silver crystal towards the left side of the PCB as circled below.
