Coleco ADAM Floppy Drive Controller/Power Supply PCB Repair Guide

Rev. A

By John Lundy

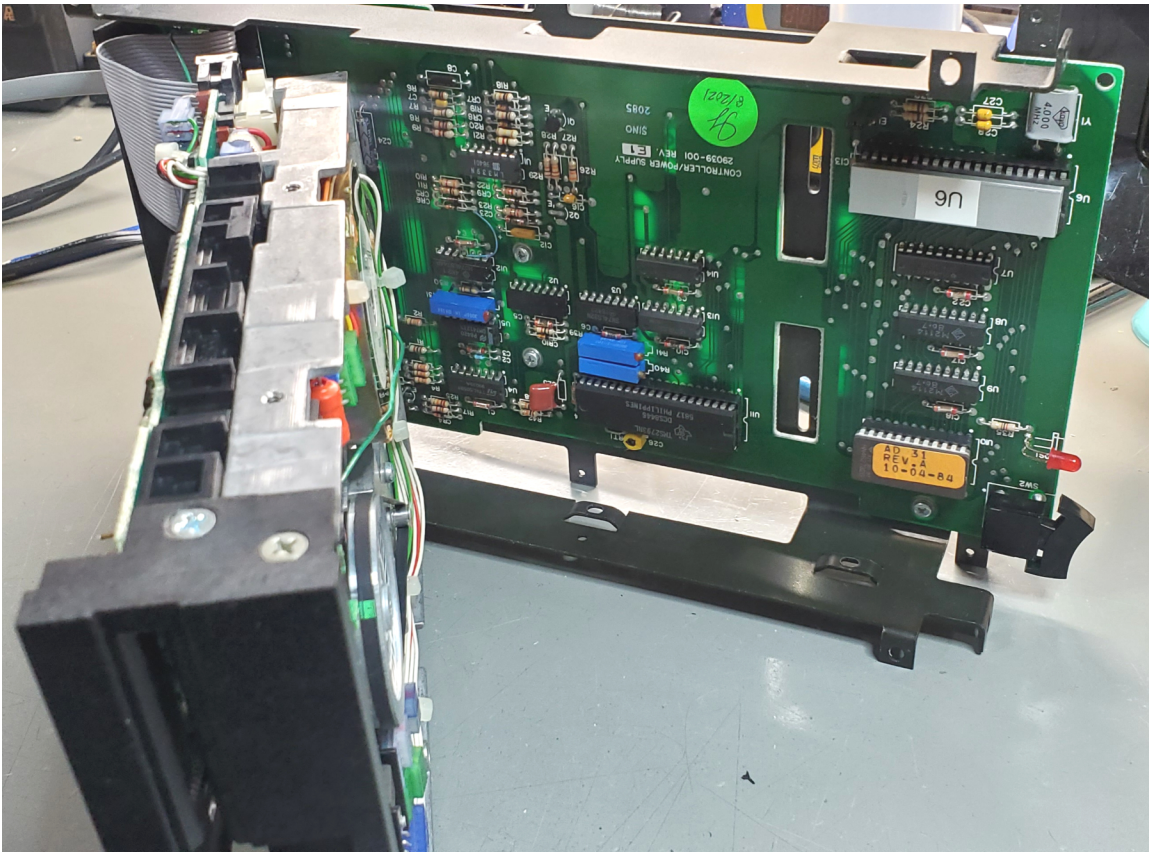
Figure 1

Power OFF and unplug the power inlet cable. Place the drive and Controller PCB on their side facing the operator without using any drive mounting screws. Pull the drive portion away from the main controller as much as possible to expose as much of the Controller PCB as much as possible while being careful to not pull out or loosen any cables in the process. See *Figure 1*.

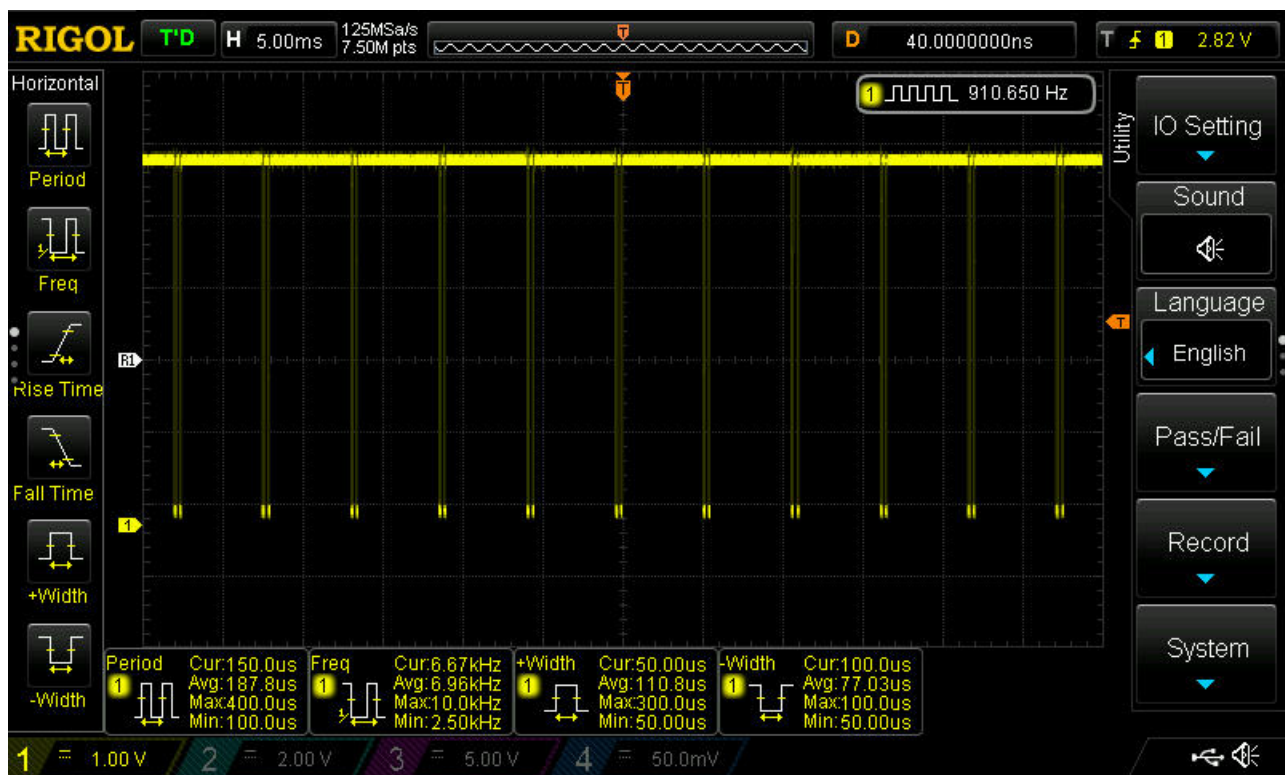
Figure 2

If the drive spins continuously after the console is turned ON, there may be an ADAMnet issue. Verify ADAMnet data input is seen at U6 pin 11. If data is not seen at U6 pin 11, verify the ADAMnet cable is good and inspect the drive “IN” ADAMnet connector for damage or broken or shorted pins. If the connector is fine, further troubleshooting is required using the schematic. U1 is a possible failure point or the U6 6801 itself. See *Figure 2*.

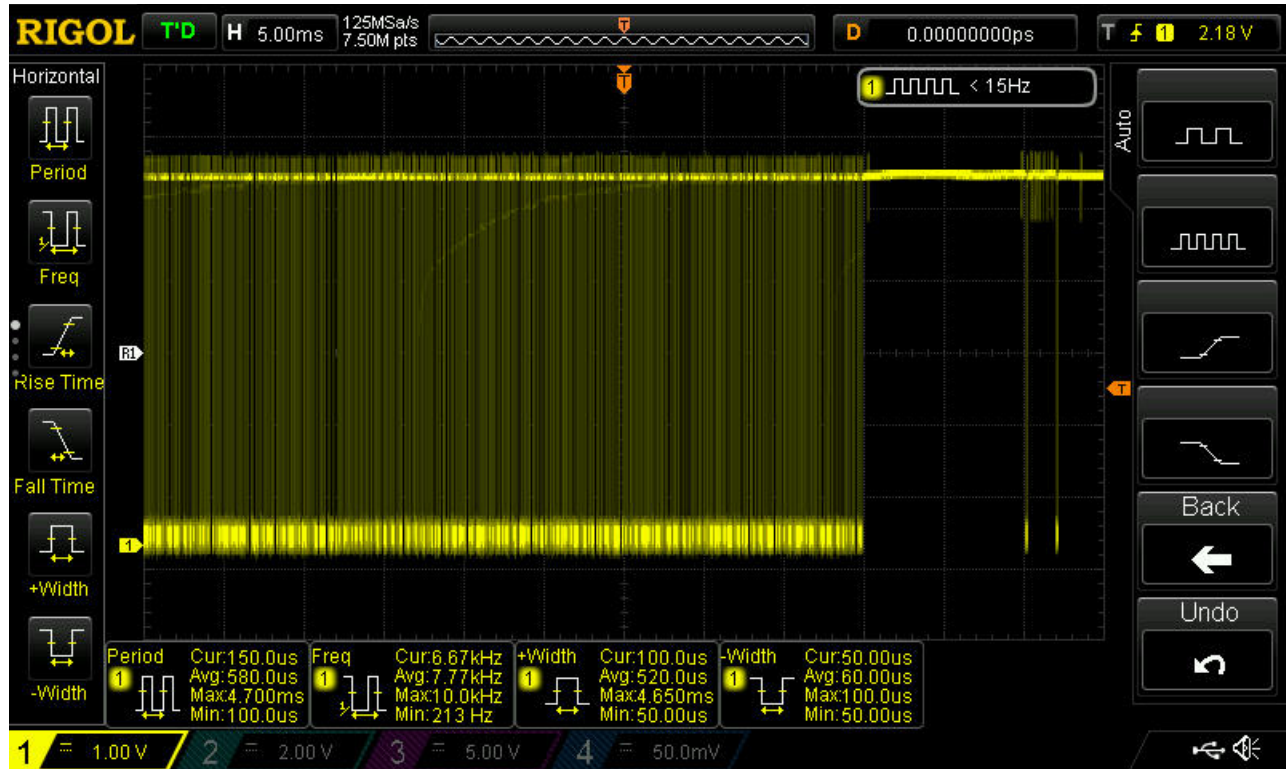
Figure 3

If ADAMnet data input shows data, verify ADAMnet data output on U6 pin 12 while performing an action that will initiate a disk drive read from the console. If data is seen, ADAMnet is working. If data isn't seen, further troubleshooting is required using the schematic. U1 and Q1 are possible failure points or U6 6801 itself. See *Figure 3*.

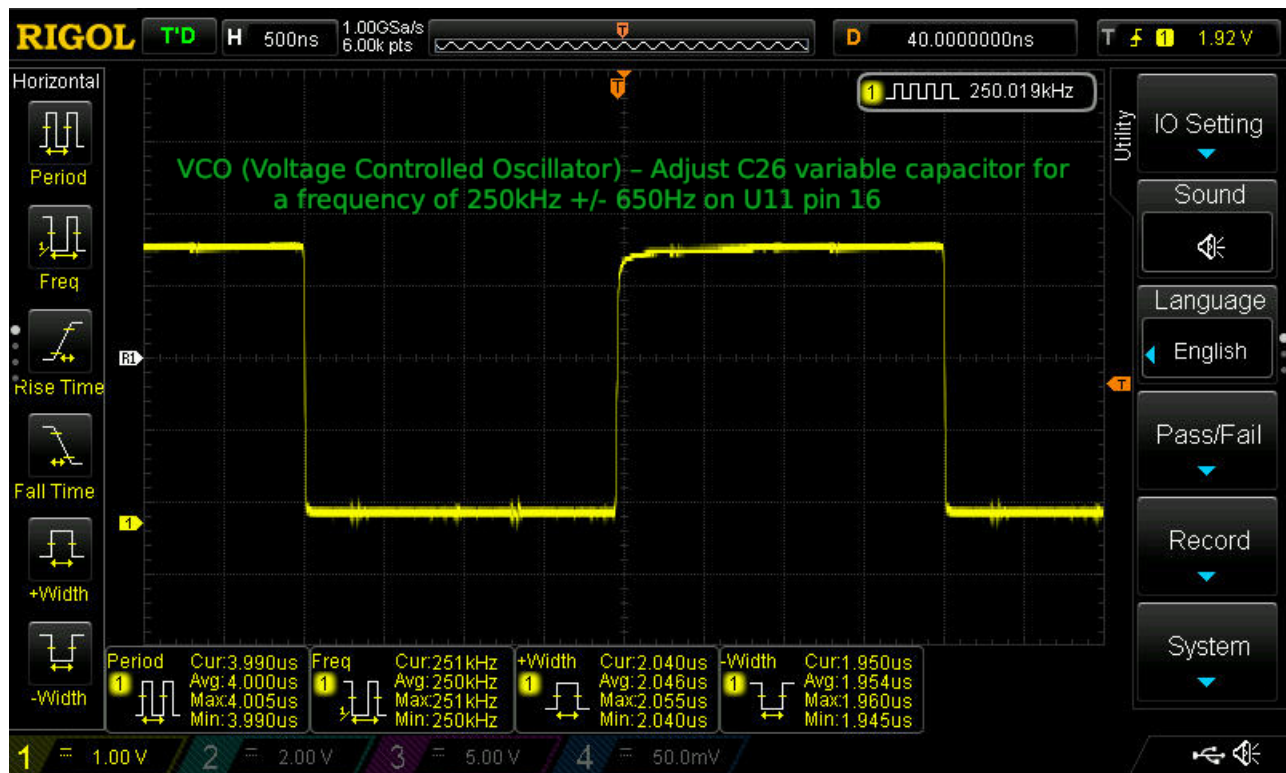
Figure 4

Perform a VCO (Voltage Controlled Oscillator) adjustment by attaching the scope probe to U11 pin 16. The VCO frequency should read 250kHz +/- 650Hz. If the frequency is not in this range, adjust C26 variable capacitor as close to 250kHz as possible. If the frequency can't be adjust in range, it's possible C26 or U11 is faulty. See *Figure 4*.

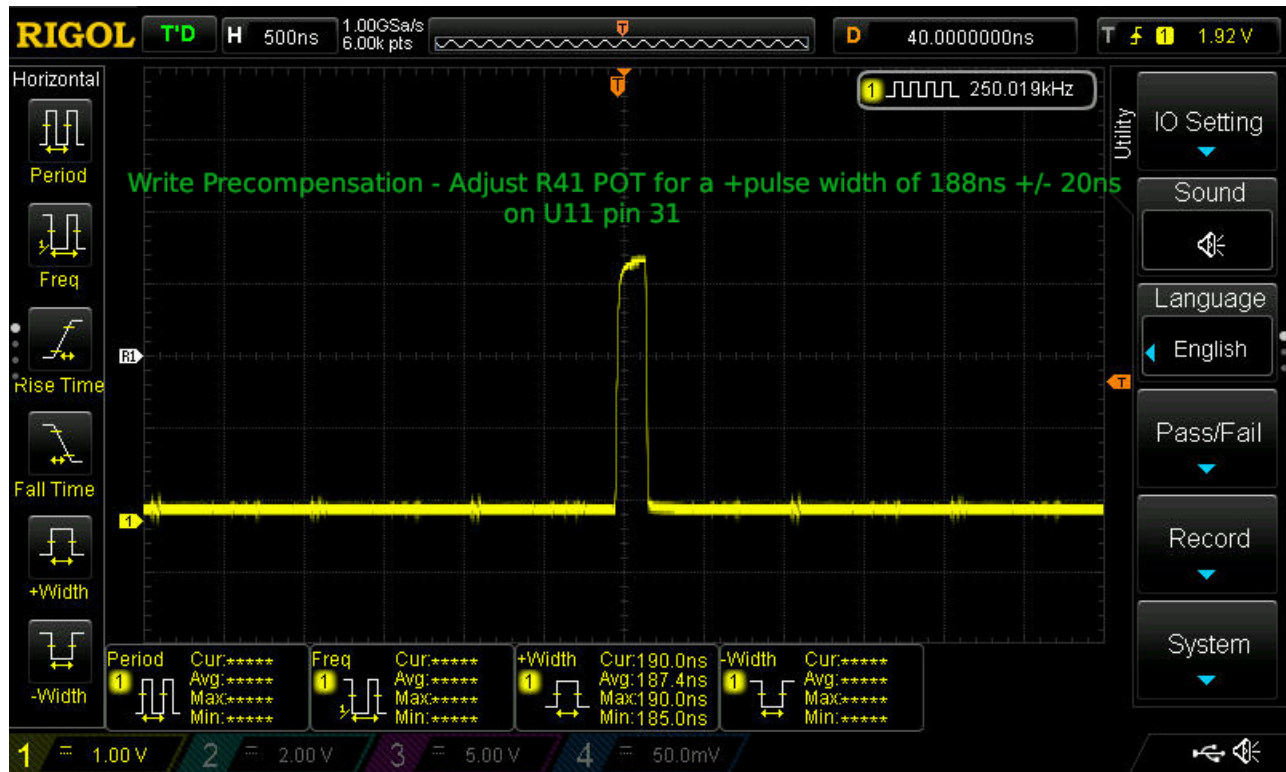
Figure 5

Perform a Write Precompensation/WPW adjustment by attaching the scope probe to U11 pin 31. It should have a positive pulse width of 188ns +/- 20ns. If it is not in this range, adjust the R41 potentiometer as close to 188ns as possible. If it can't be adjusted in range, it's possible R41 or U11 is faulty. See *Figure 5*.

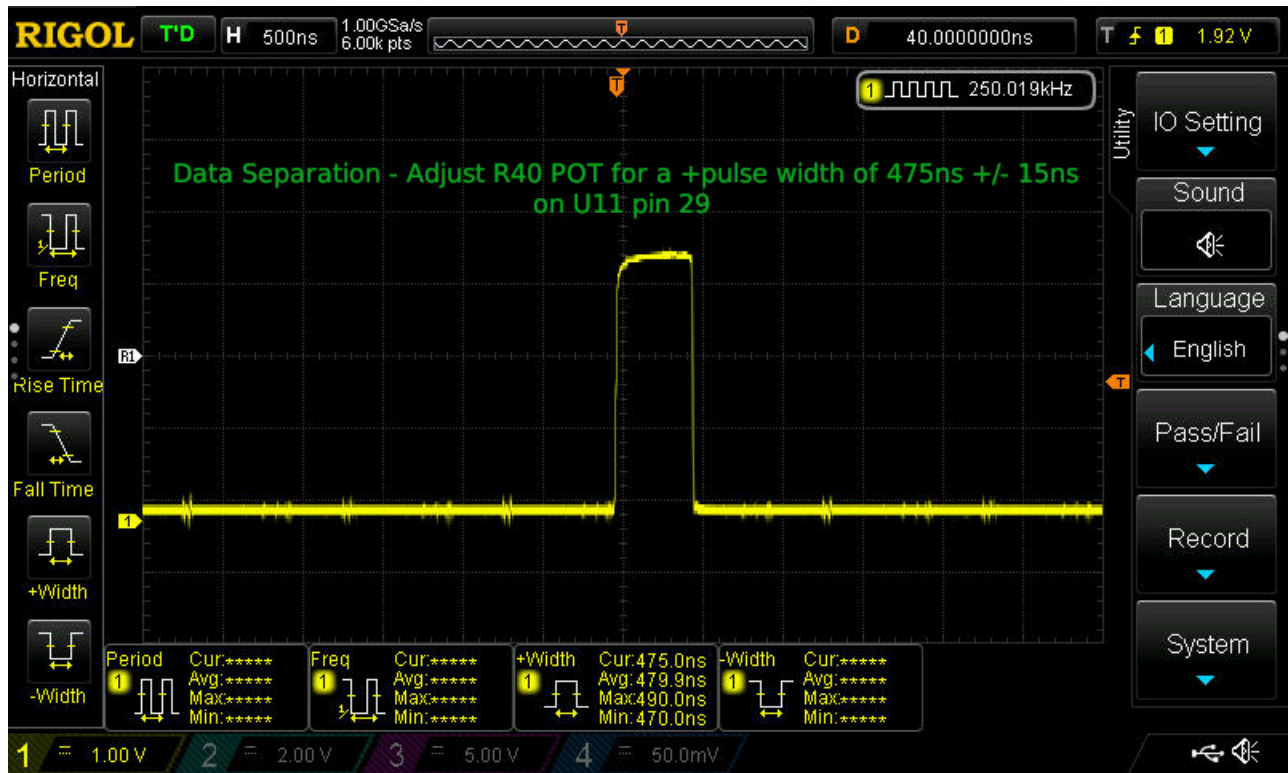
Figure 6

Perform a Data Separation/RPW adjustment by attaching the scope probe to U11 pin 29. It should have a positive pulse width of 475ns +/- 15ns. If it is not in this range, adjust the R40 potentiometer as close to 475ns as possible. If it can't be adjusted in range, it's possible R40 or U11 is faulty. See *Figure 6*.

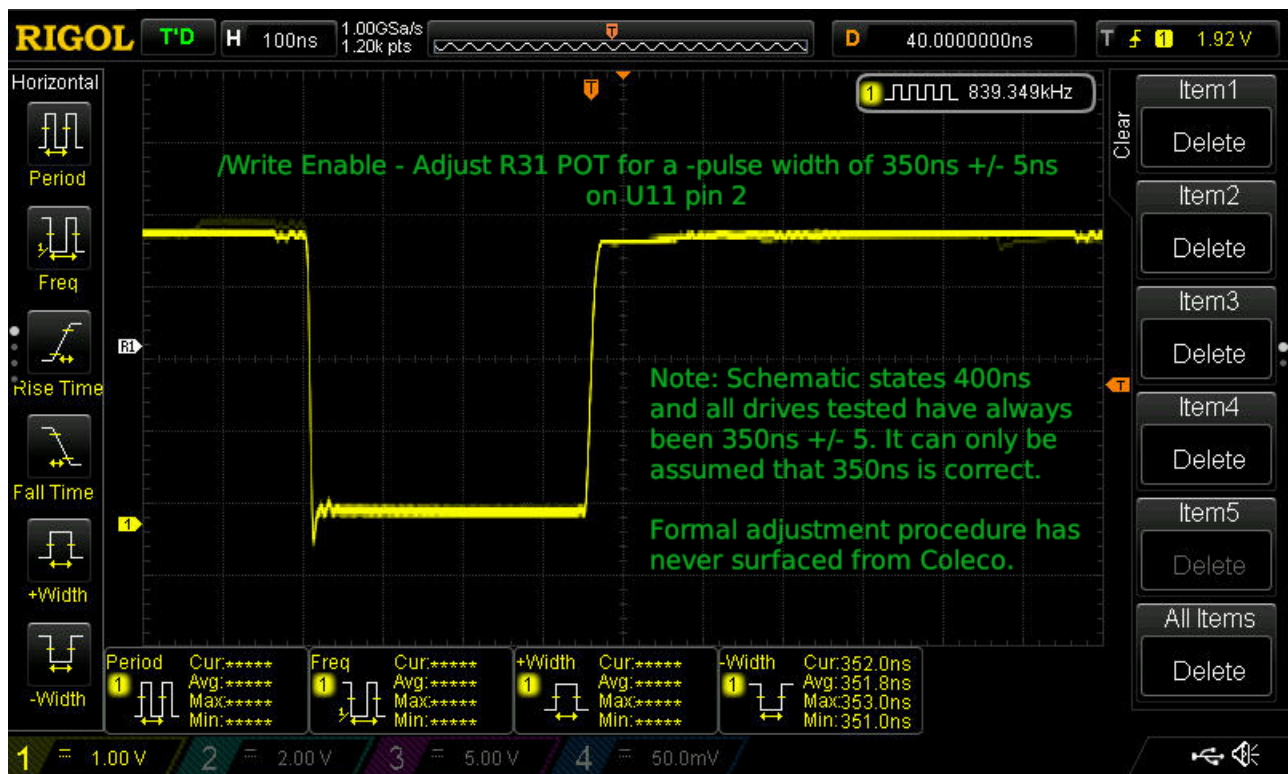
Figure 7

Perform a Write Enable/WE adjustment by attaching the scope to U11 pin 2. It should have a negative pulse width of 350ns +/- 5ns. If it is not in this range, adjust the R31 potentiometer as close to 350ns as possible. If it can't be adjusted in range, it's possible U5, U13, U14, R30, C2, or U11 might be faulty. See *Figure 7*.
